Stress Tests and Mechanical Strenght of Remoran Wave 3

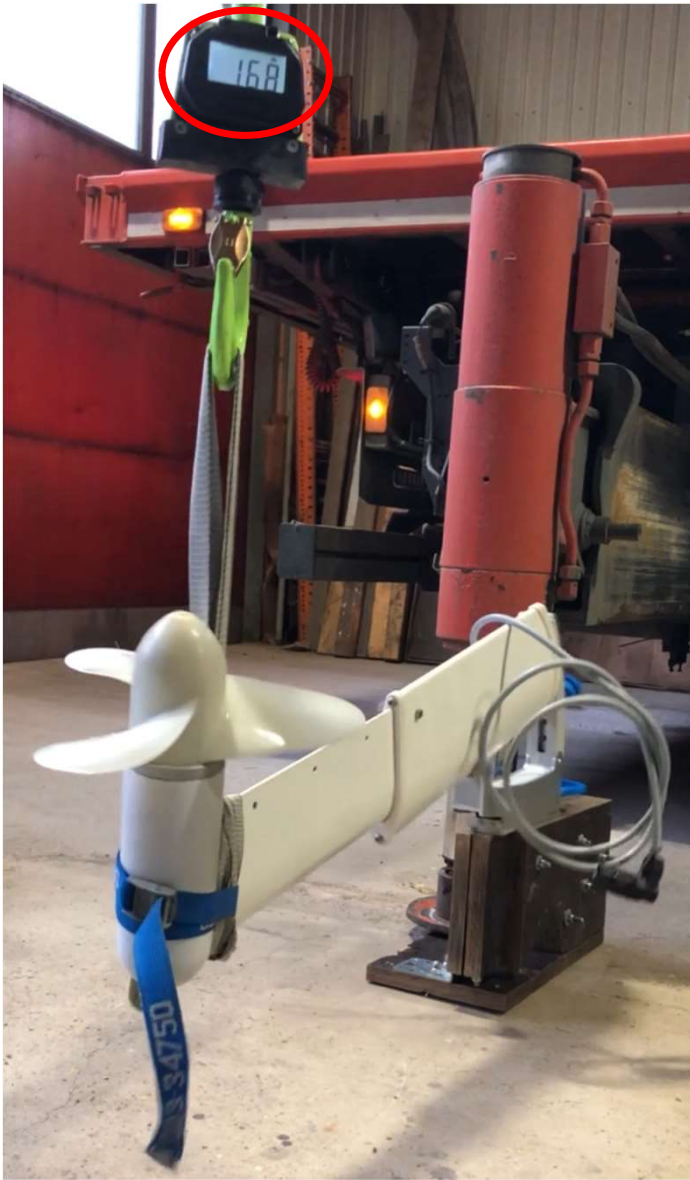
Limit of mechanical fuse – 168 kg
Test was performed with a crane
and the outboard unit fully
extended. Actual fuse threshold on
a partially extended unit is higher.

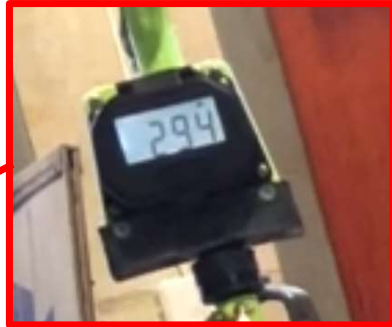
Overall mechanical endurance of the outboard generator unit exceeds 294 kgs, which was the limit of test setup as the screws used to attach the rail to a block of plywood came loose. The outboard unit itself suffered no damages and remained fully operational after the testing. The only event was the triggering of the mechanical fuse as intended.
